WINCHESTER PUBLIC SCHOOLS  
FACILITIES MASTER PLAN

REPORT PREPARED BY

JULY 25, 2017

## Master Plan Update

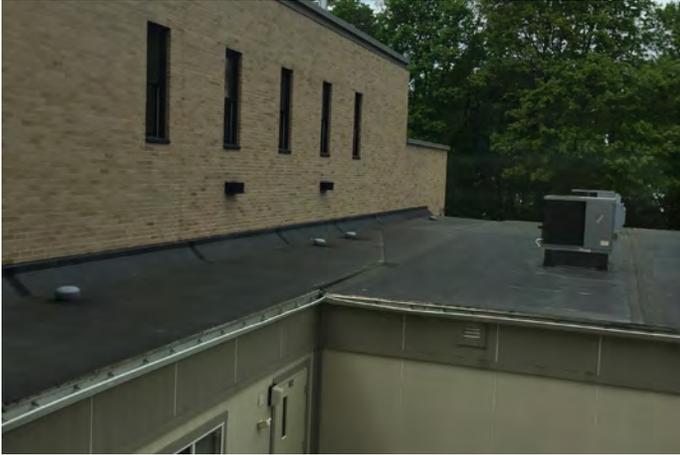
*Roof conditions*

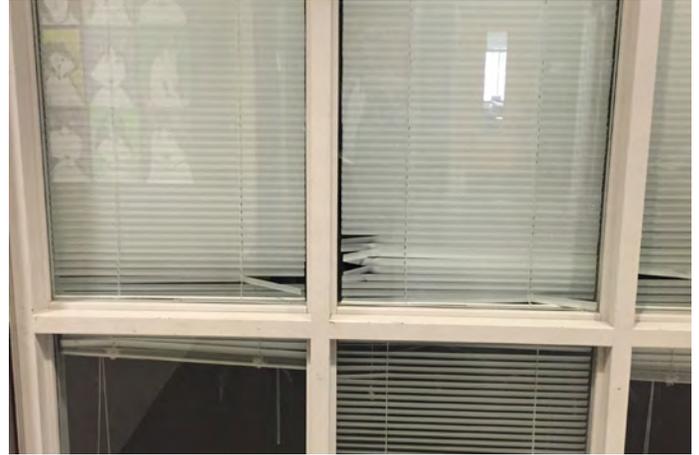
*Windows at exterior*

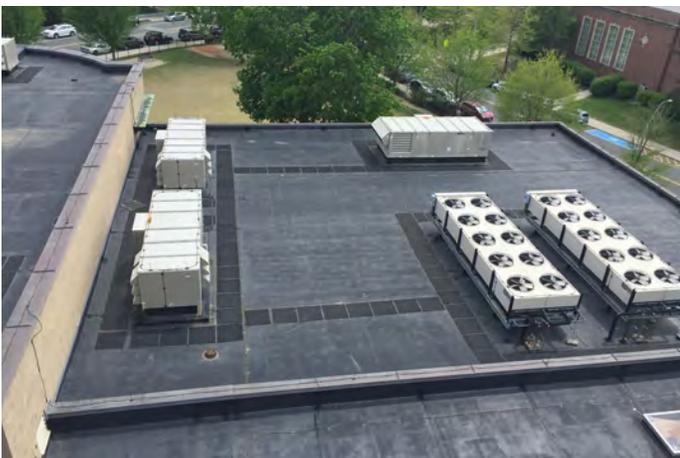
*Roof conditions*

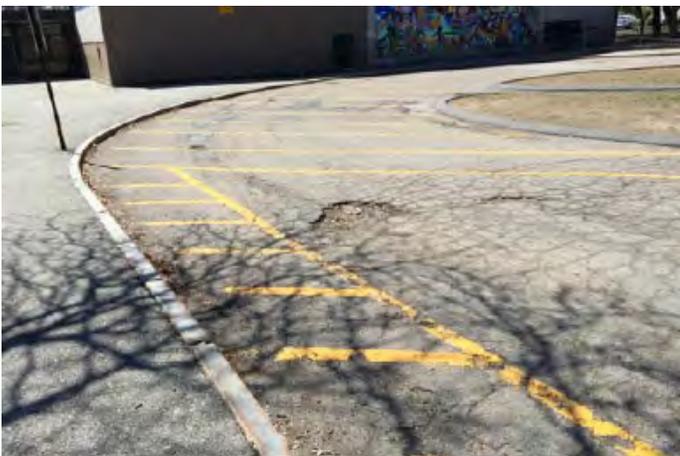
*Poor quality of pavement at drop-off loop*

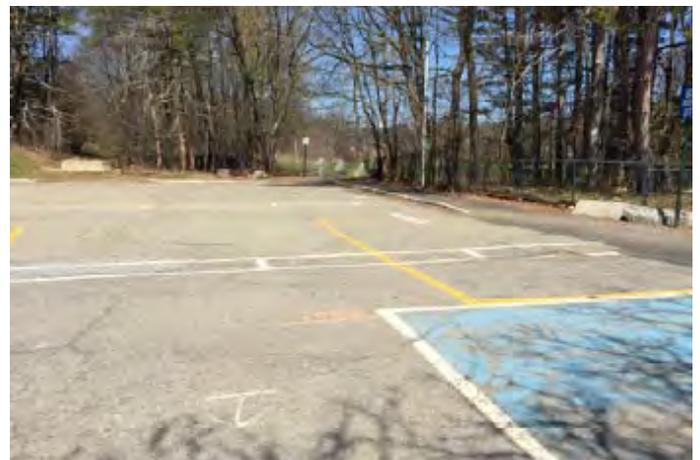
*Confusing pavement graphics at Brantwood lot*

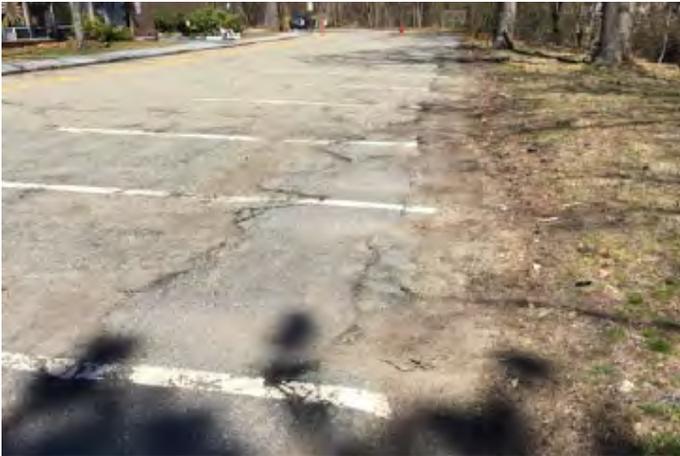
*Staff parking on east side of building with broken edges*

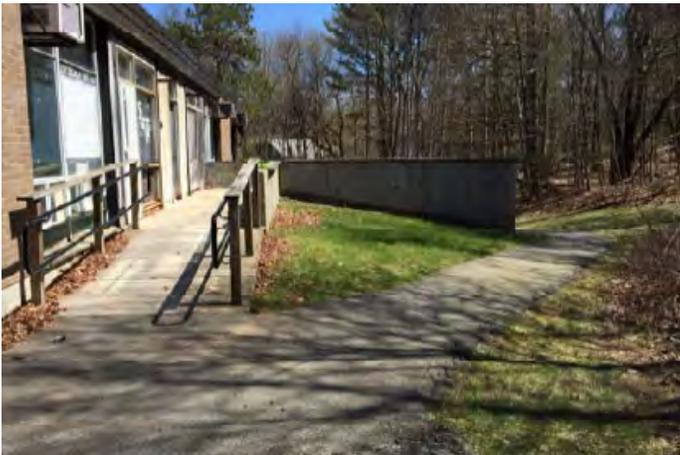
*Wood ramp at Doors 7-9, asphalt path slopes steeply*

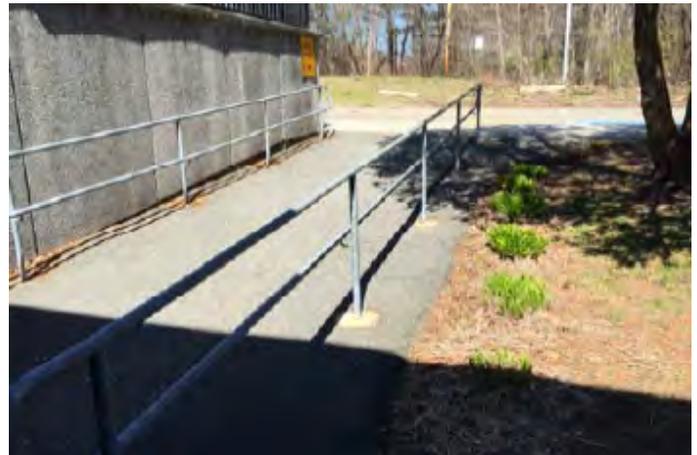
*Asphalt ramp to Door 3 may or may not be compliant*

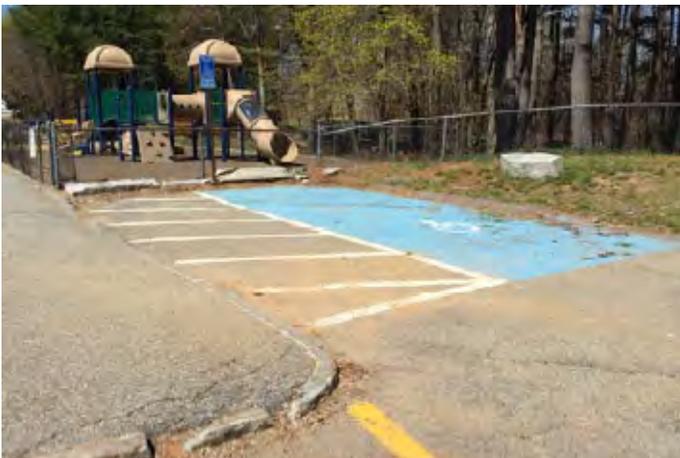
*Van accessible space off HPR dro-off loop in poor condition*

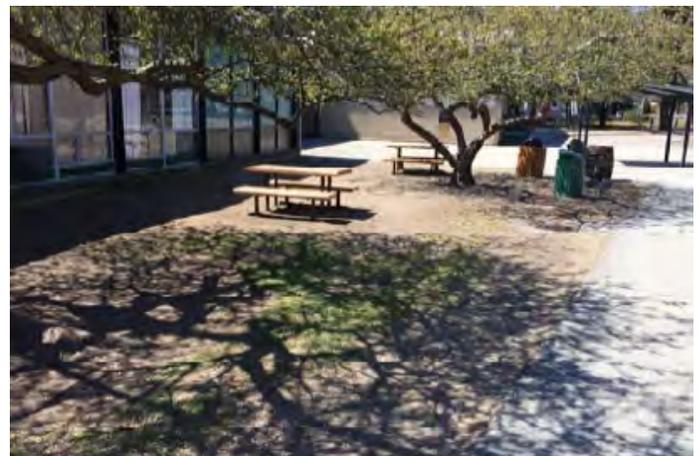
Lawns, where they are away from foot traffic (such as along the building face by the roadway) are in reasonable condition. But the lawns surrounding the plaza are heavily trampled and compacted.

*Picnic table on trampled lawn beneath crabapple trees*

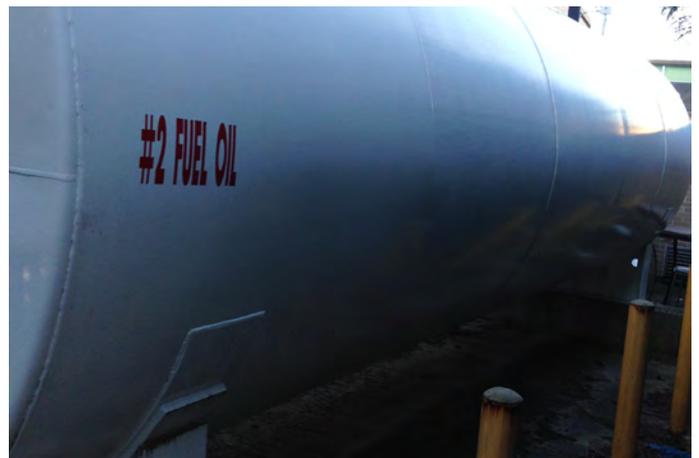
*No containment berm or walls around fuel tank*

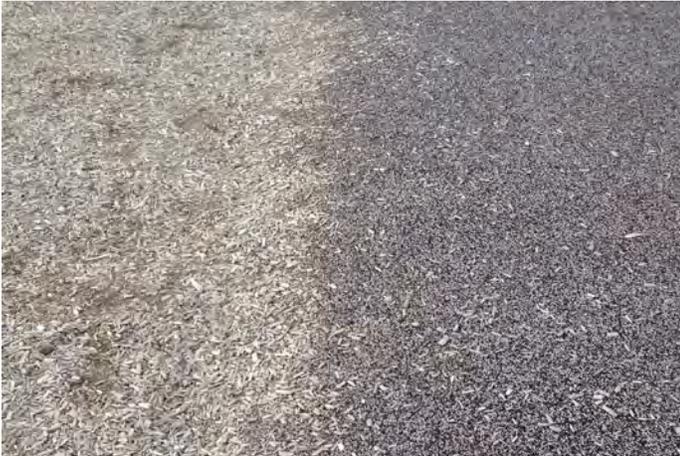
*No separation between two playgrounds*

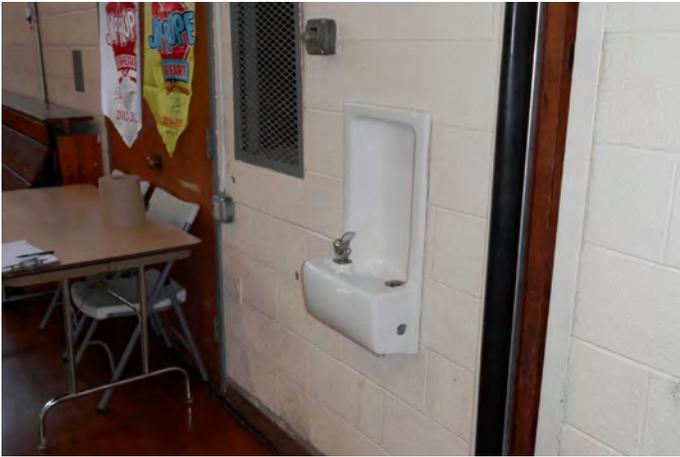
*Drinking fountain on exposed brick wall*
