ABERJONA RIVER HISTORICAL BACKGROUND

**Prepared by Ellen Knight
For the Town of Winchester's Flood Mitigation Program**

Updated 12/12/2017

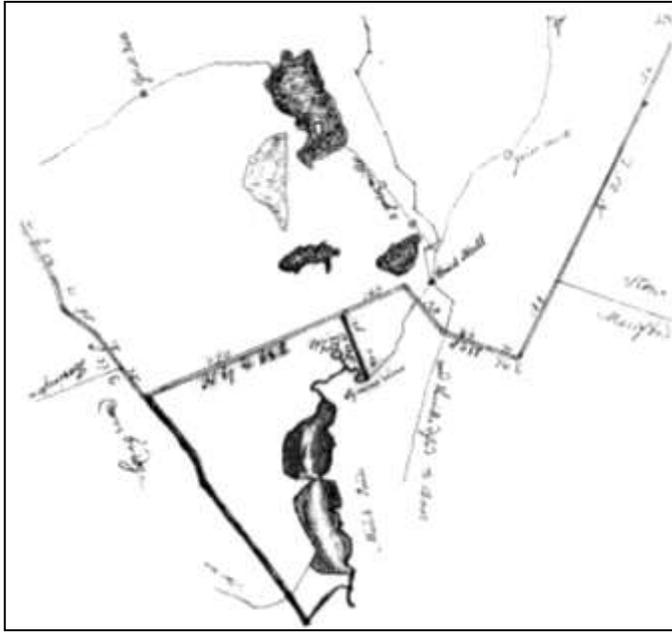
MAP 1 - 1794

MAP 1 (left) is a composite of 1794 maps of Woburn and Charlestown. While marking the entire course of the river through Winchester, it reveals nothing about the character of the river. It does show how Horn Pond Brook originally bypassed Wedge Pond and emptied into the Aberjona. It also shows the Spring Pond now under the Upper Mystic Lake.

The features pictured include (top to bottom) Horn Pond, Horn Pond Mountain, Winter Pond, Wedge Pond, Spring Pond, and Mystick Ponds.

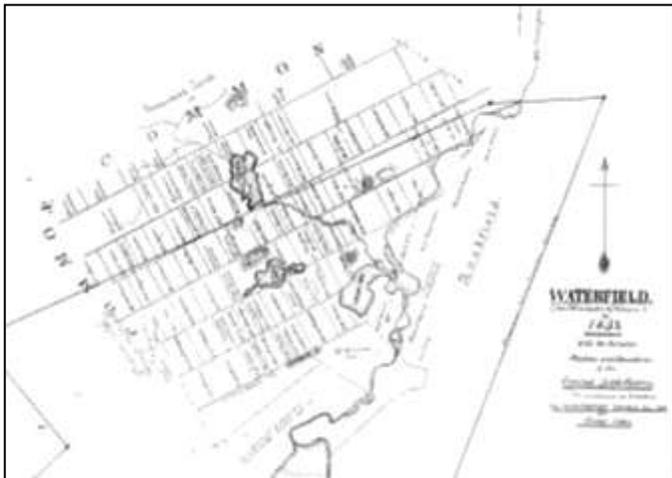
MAP 2 - "Waterfield 1638" drawn in 1886

Caution: Although a map of "Waterfield (now Winchester & Woburn) in 1638" exists, it was drawn in 1886 by local historian George Cooke and must not be viewed as a Colonial map. Certain features of the river on his map can be identified as post-1638 man-made changes (which will be noted in the appropriate places). It is better to refer to maps to which Cooke had access (as is done herein), including the 1706 and 1769 Symmes plot plans and 1854 town map.

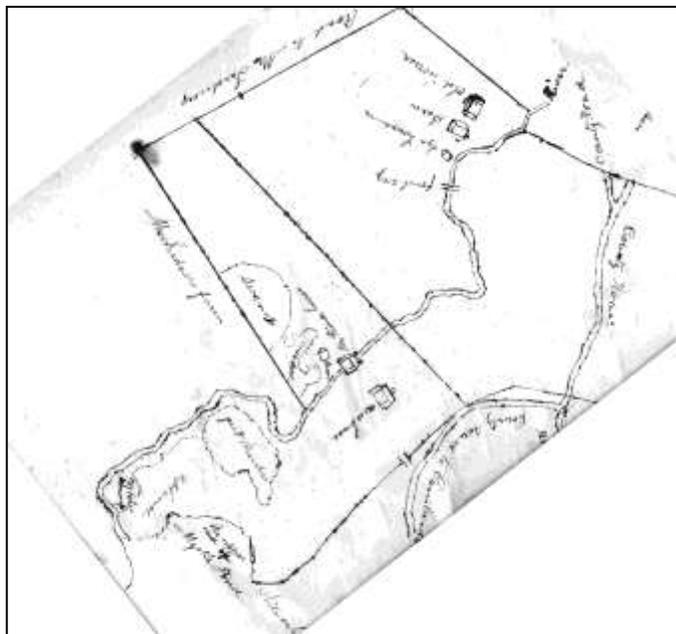
MAP 3 - 1705

· Symmes/Bacon Mills & Dams

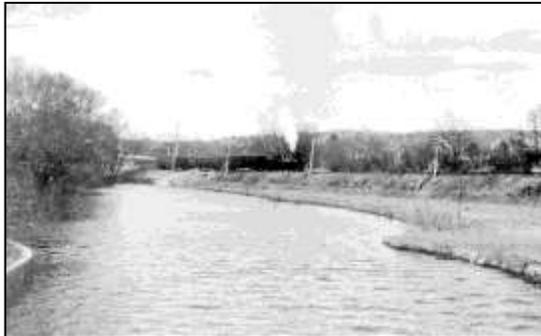
The southern end of the Aberjona downstream of the Wedgemere train station in 1901.

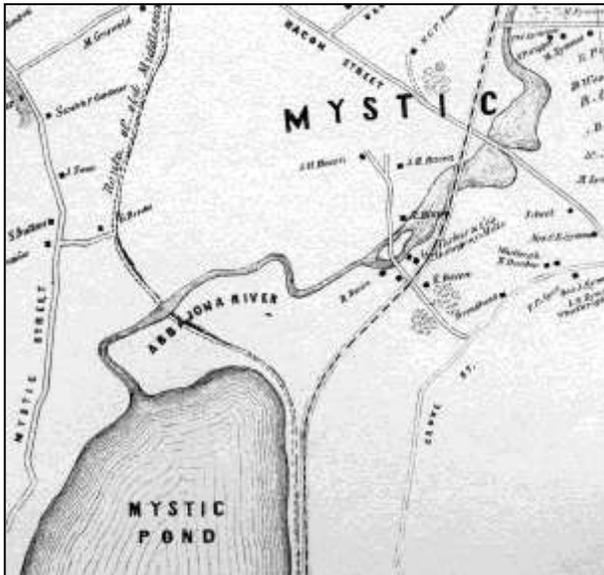
MAP 6 - 1854

The First Map of the Town after Incorporation

- Middlesex Canal - the Canal, which opened in 1803, went along the east side of the Lake and crossed the Aberjona to the north of the old pond (see MAP 6). The construction of the canal reportedly helped drain a considerable amount of the territory.
- Railroad - In 1835 the railroad embankment was built to carry the track between Bacon's mill and a bridge over his roadway that led down from Grove Street. The train station was originally to the north of the Bacon Street Bridge (see MAP 7).

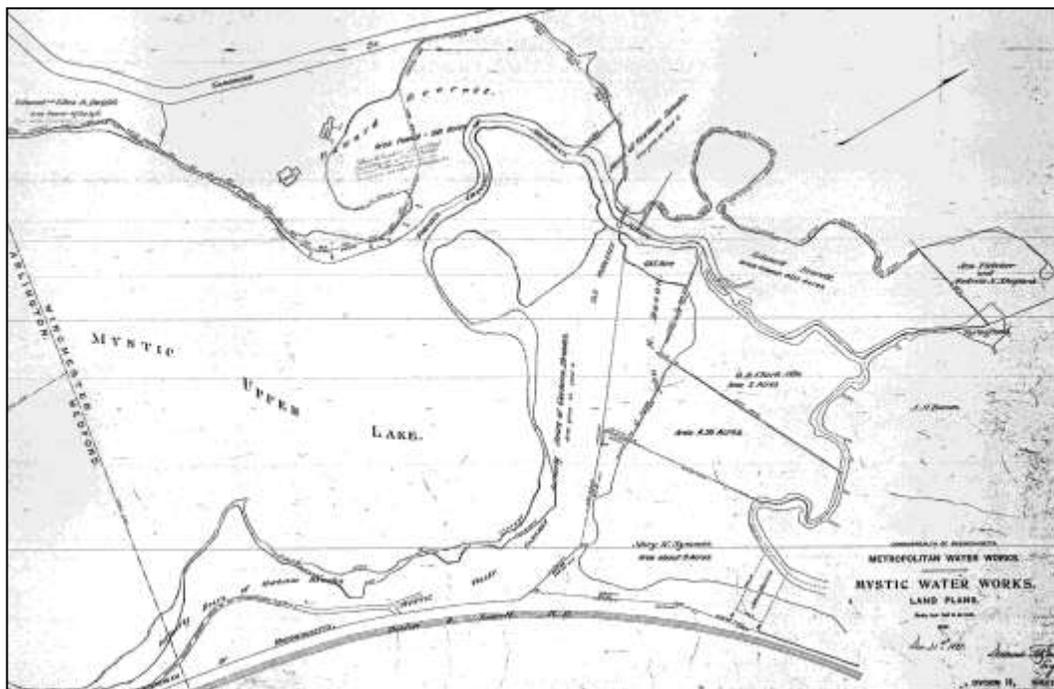
MAP 8 - 1897 Showing the original channel of the Aberjona River and the flowage resulting from the construction of the Mystic Dam in 1864

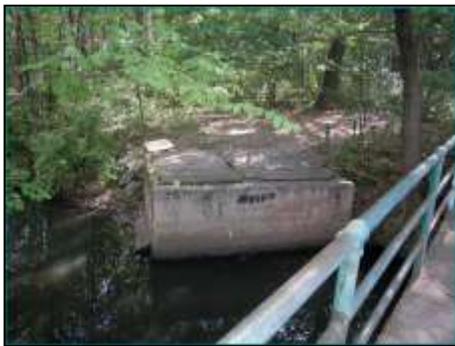
- North Metropolitan Relief Sewer built in 1937 – left siphon jutting into the river near Wedgemere train station.
- 2006 - MWRA filed notice of intent with Conservation Commission to move siphon. Project completed in 2007.

Flood Mitigation Project:

Siphon moved

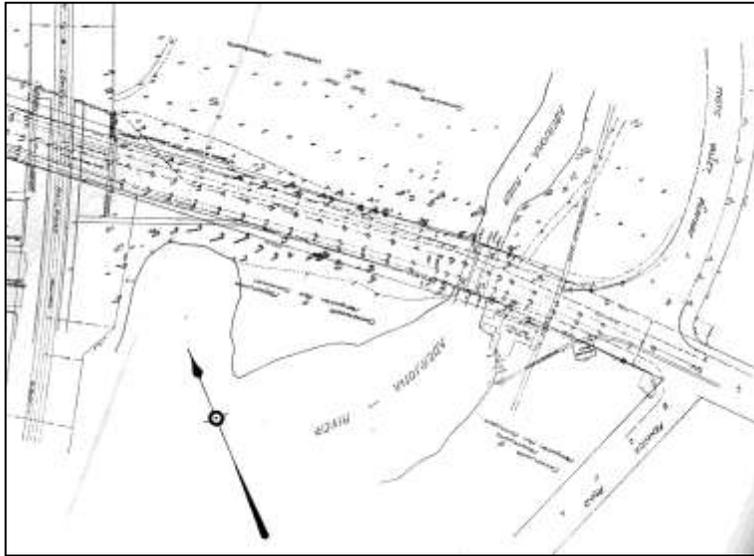
MAP 11 – 1919
Topographical Plan for Bacon
Street Bridge Construction

The first stone bridge to replace wooden bridges at this site was built in 1874. That bridge was formed of three box culverts. Collapsing, it was replaced in 1922 by an arch bridge, designed by Ralph S. Vinal and engineered by J. R. Worcester & Co. That bridge was rehabbed in 1996.

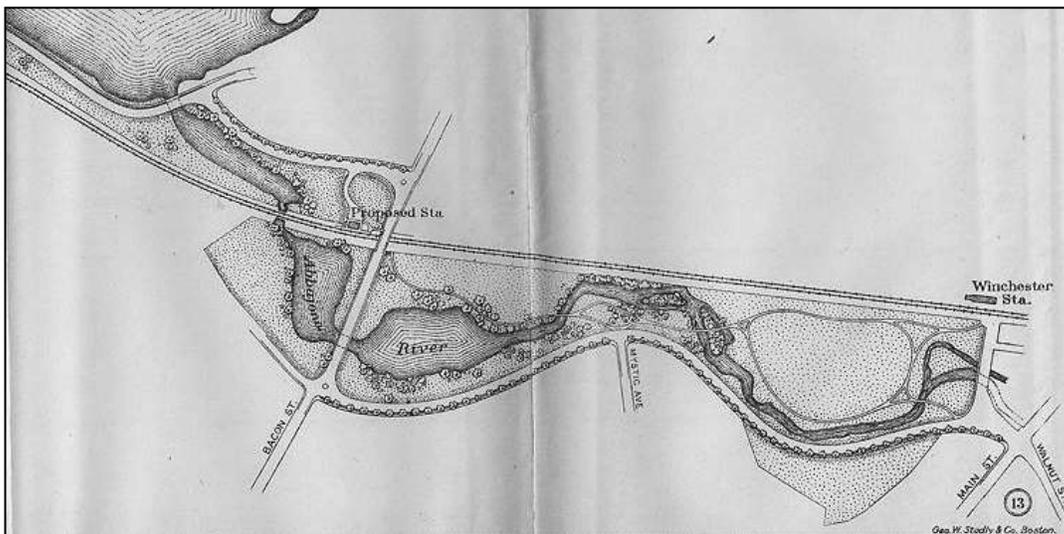
Map 12A - 1895 Olmsted, Olmsted & Eliot design for Mystic Valley Parkway

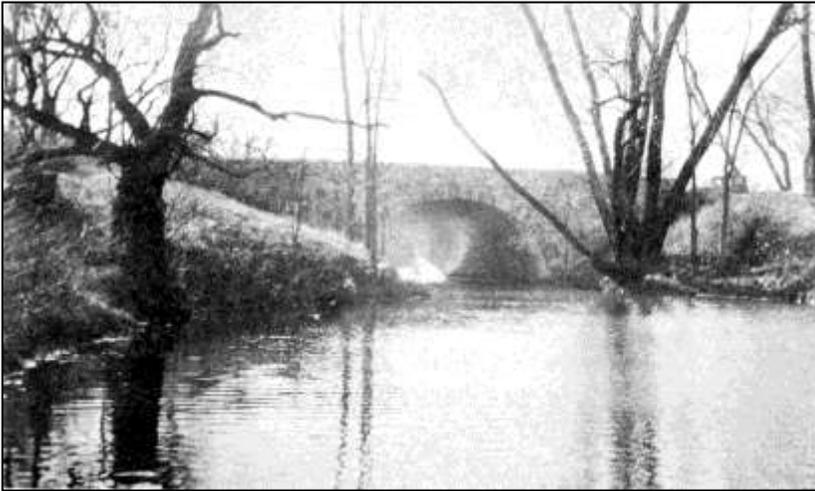
Bacon Street Bridge
photographed from
upstream in 1928 showing
the river expanding into a
pool.

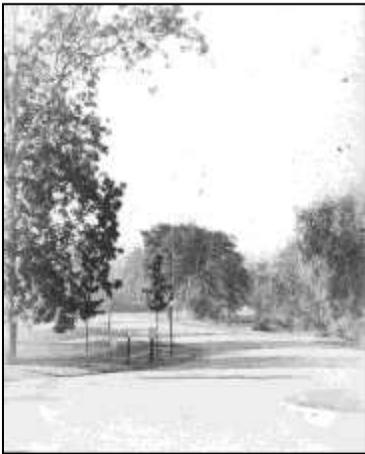
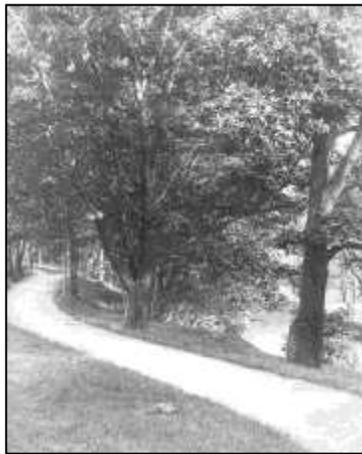
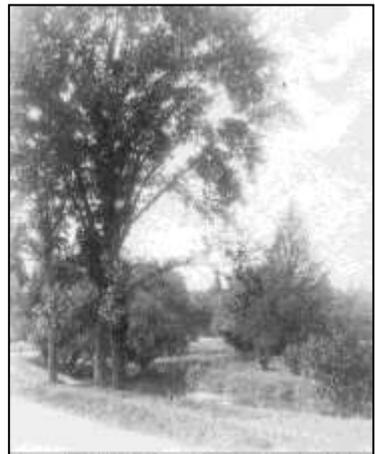
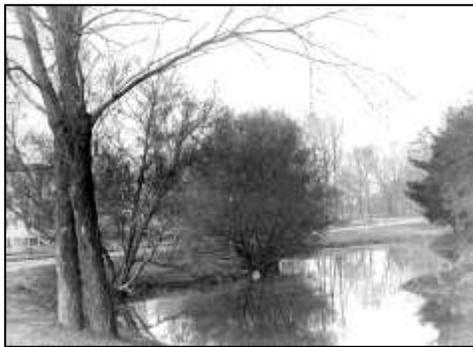
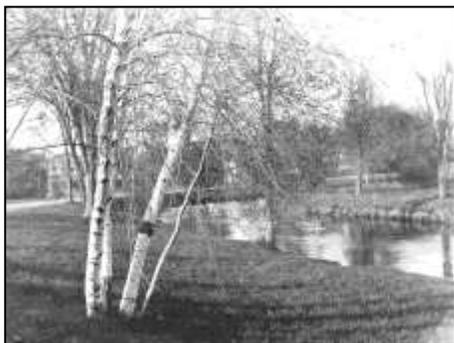
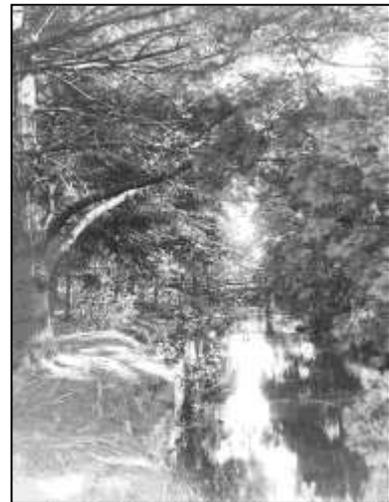
Views of the southern channel about 1900, going north to south

Walnut Street bridge was full of refuse and rubbish. Along the shore were many dead eels, and the river was covered with scum at several points. Many street drains emptied into the river. The channels around the islands were almost filled with accumulations of street washings. In 1915 the MPC agreed to clean out, regrade, and improve the shores from Bacon Street to Mill Pond.

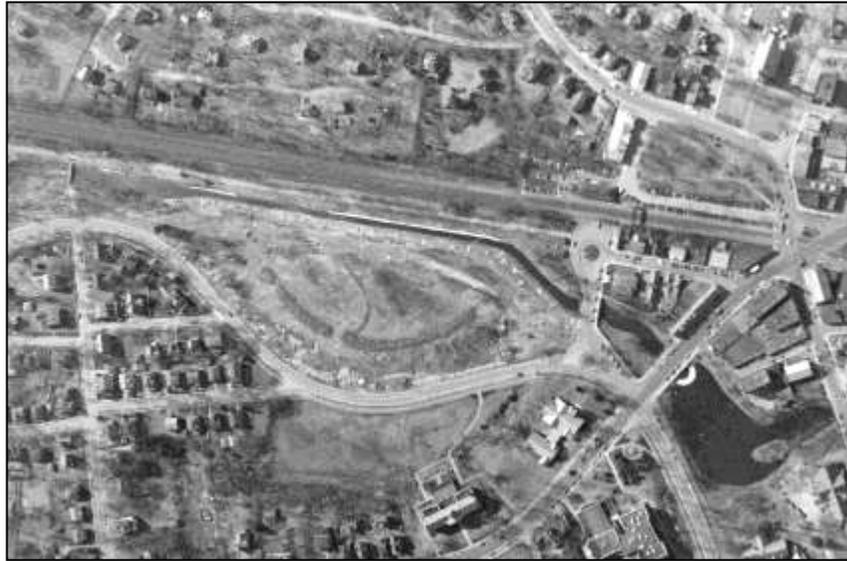
Photograph taken after the river had been moved but before the parkway had been moved parallel to it.

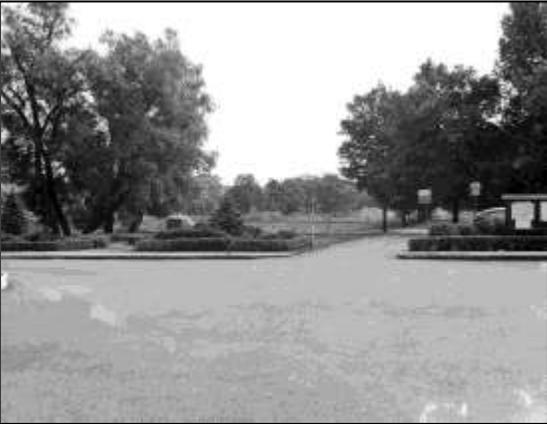
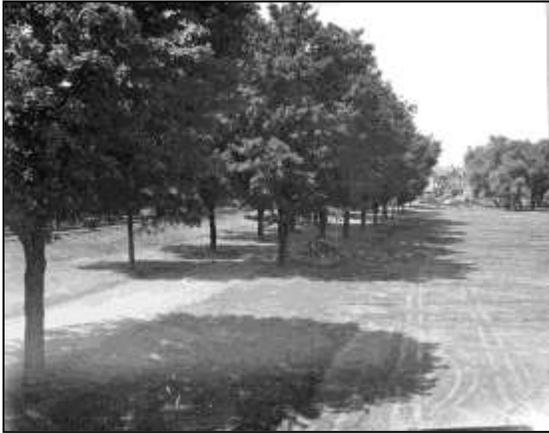
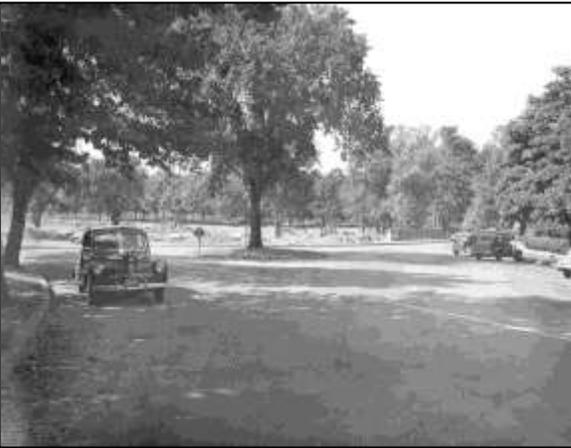
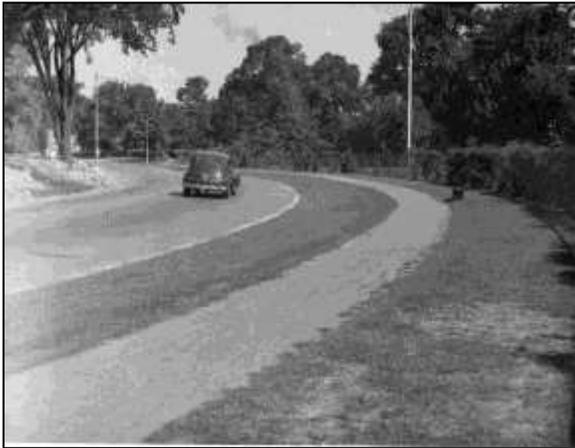
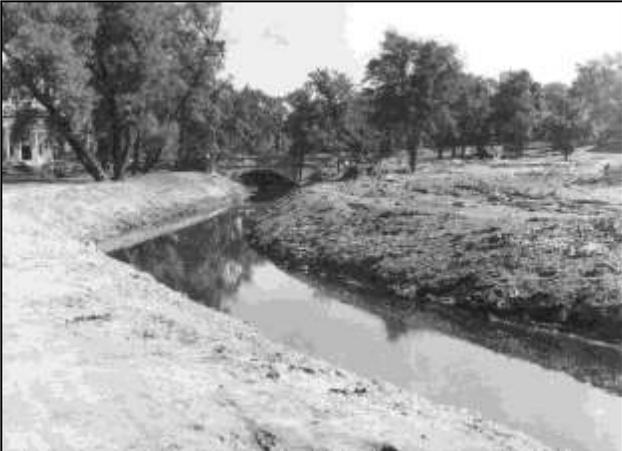
Views of the original Manchester Field as work to move the river was beginning, 1946

- 1946 – channel from Mystic Avenue to Waterfield Bridge straightened. In the 1940s, the search for a better football field led to the last major alteration in the course of the Aberjona River, the moving and straightening of the channel between Waterfield Road and Mystic Avenue. Football was being played on the Shore Road Field (see Judkins Pond section, below), which was built on a filled-in swamp and could not stand up to the wear and tear. Of the several solutions suggested (against some opposition from those who wished to keep the winding, country-village nature of the river), Town Meeting endorsed Town Engineer Parker Holbrook’s proposal to move this section of the river next to the railroad, moving the parkway next to it, and rebuilding a larger Manchester Field in its present location. That project included riprapping the western banks, removing trees, and grading the field.

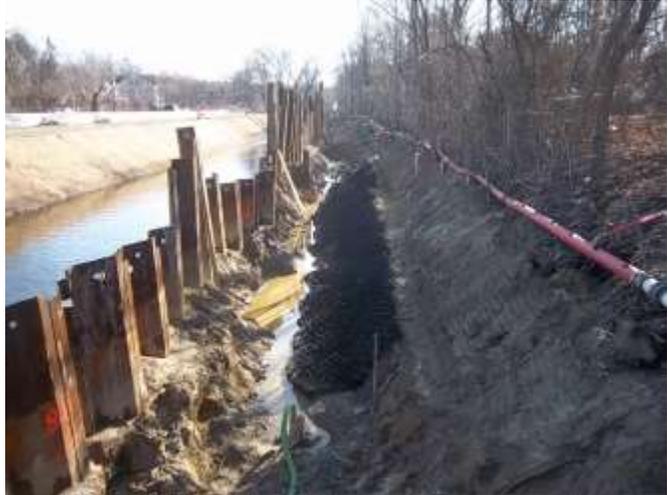
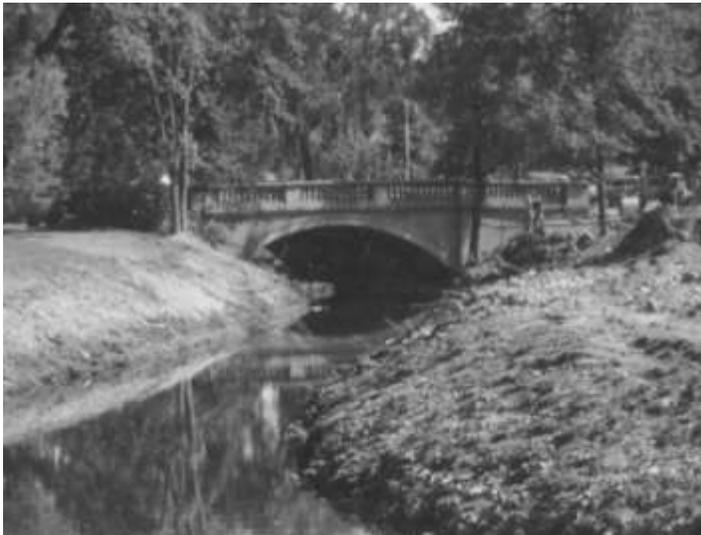
Flood Mitigation Project:

Channel Widening

- 2011-2012 – Project #2 of the Flood Mitigation Program was implemented to widen the channel between the Waterfield Bridge and Mystic Avenue and level the river bed down to Bacon Street.

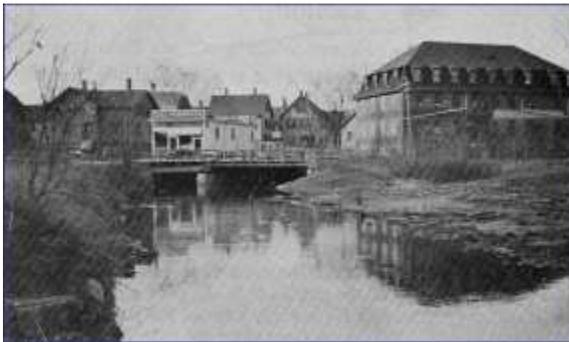
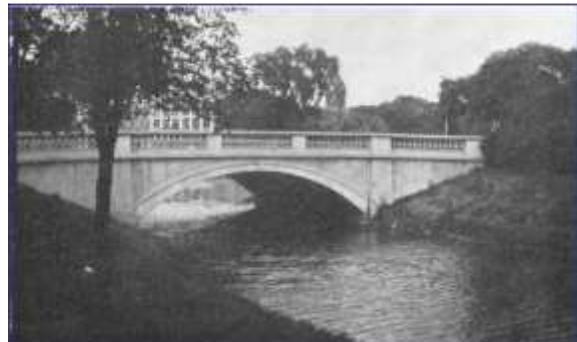
Above: The Walnut Street bridge, site of the Waterfield Bridge (right). Note condition of banks.

- 1913 – raceway filled. The raceway, which had been used as a general catchall for rubbish by townspeople, was mostly filled by dumping Town ashes into it.
- 1914-15 – new bridges and dam built (see below), designed by Kellaway.
- 1914-15 – single channel cut leading out from the pond. On Kellaway’s recommendation, a new, single channel with firm banks was made between Walnut Street (Waterfield Road) and Main Street.

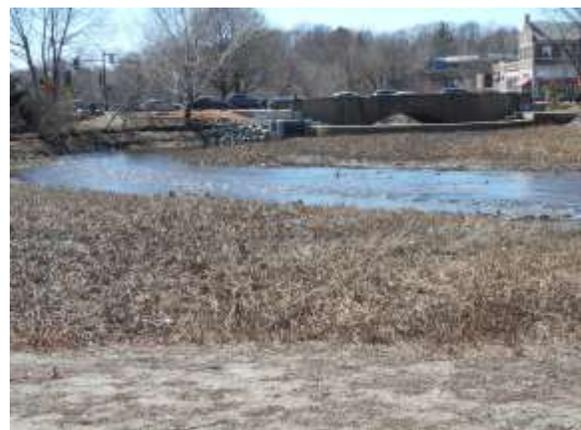
Pond condition in 2017, while water was diverted for the Mt. Vernon bridge project

- 1962 - the channel from Judkins to Mill Pond was dredged, a Chapter 91 project recommended in 1957.
- 2017 - a fourth culvert was added to the existing bridge and a new railing installed. The project also revealed existing conditions of the pond.

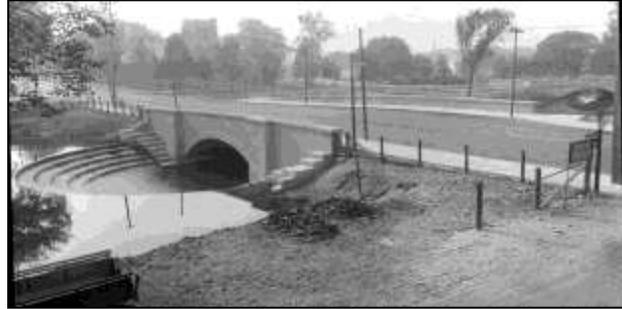
These three structures were designed by Kellaway and constructed during 1914 and 1915. The Converse Bridge with an arch span of 35 feet, replaced an old stone girder bridge of two openings 70-feet wide.¹⁹

The dam has six steps, each one foot thick and three feet wide, the total descent being six feet six inches. The semi-circular shape of the dam resulted from the need to meet the required width.

Removing the top step to lower the crest was discussed in the 1950s but not executed. In 1956, the Park Commissioners reported, “We are informed by the State and Town Engineers that the water level by the railroad bridge on the new By-Pass is so high that the frost, during the winter months, might cause this particular area to ‘heave.’ To correct this trouble it will be necessary during the cold weather to lower the water level in the Mill Pond. It is planned to do this by eliminating entirely the top step of the present dam.” Dredging the river was planned, as preparation. As the state was to do this, work was delayed until 1962 when part of the river was dredged. Mill Pond was dredged in 1964. Then a new Aberjona Watershed Committee was formed.

- 1974 – Dam restored by The Penetryn System.
- 2002 – Flood Mitigation Project. One of the 30-inch valves was replaced with a 5-foot valve.
- 2013 – Second valve replaced, designed to accommodate a fish ladder.

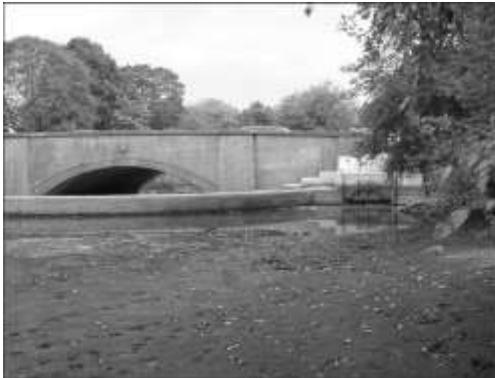
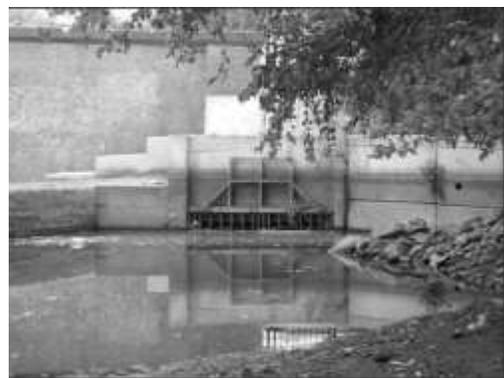
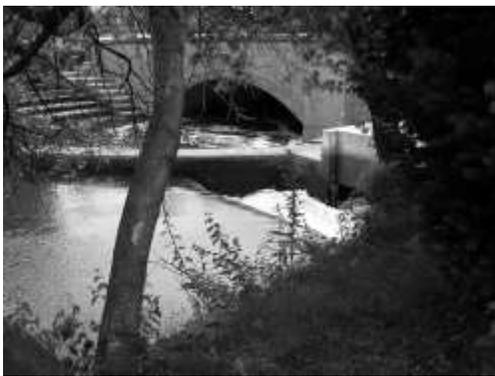
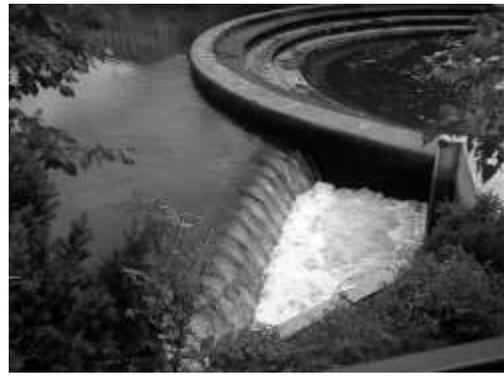
North valve at Center Falls Dam

Work on the valve disclosed the need for repairs on the dam. The design allowed for the later addition of a fish ladder.

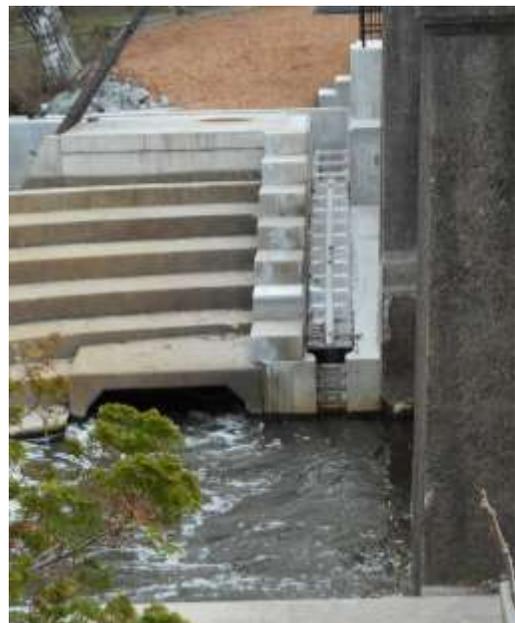
Fish ladder

A ribbon-cutting ceremony for the new fish ladder was held on Town Day 2017. Once a fish ladder was added to the Mystic Dam, the greatest impediment to the herring in their run to Horn Pond was the Center Falls Dam. Funding for a fish ladder was included among the other improvements connected with the Industri-Plex Superfund Site in Woburn.

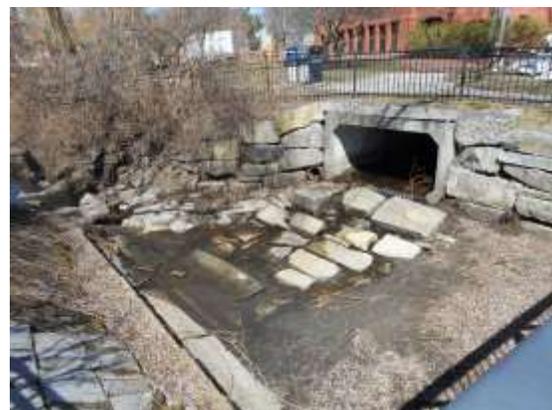
Not original to the pond, this island developed during the late 19th and early 20th centuries from the deposit of debris at the end of the culvert for an MDC sewer pipe (which may be traced back to the development of the parkway in the 1890s). It was changed from a peninsula to a landscaped island, accessible by a foot bridge, during the late 1910s or 1920s. The island underwent renovations in 1968-69, 1990, and 2001 when it was named for Sandra Rodgers, who planned and financed the new landscaping and bridge.

Sewer outlet in 2017, pictured while the river water was diverted

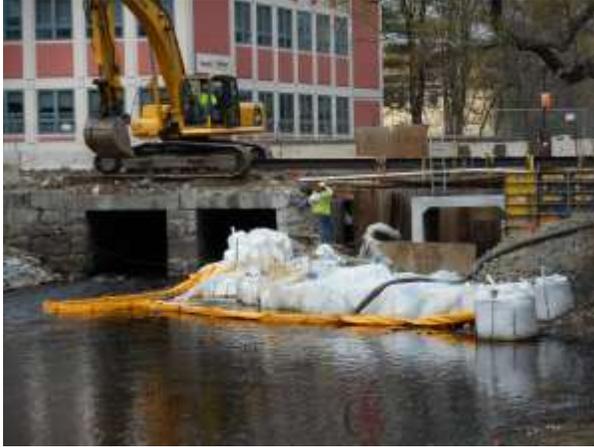
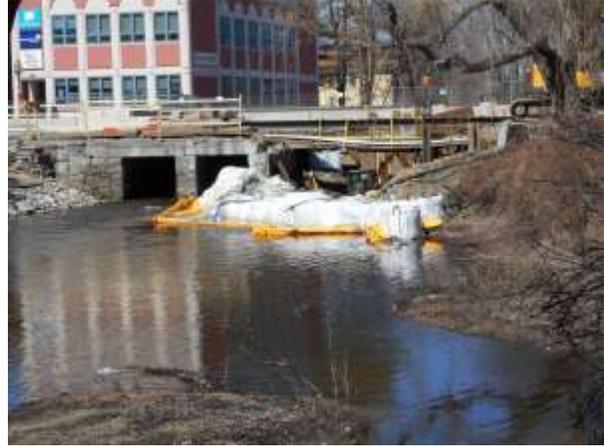
Mount Vernon Street bridge culvert

April 2017

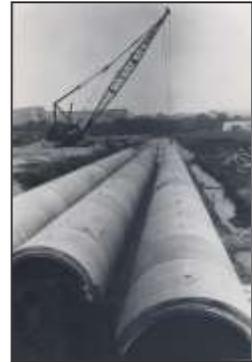
New Shore Road and Railroad Culverts
1950s

- 1954-57 – new culverts. The above project also included the replacement and reconstruction of the culverts at Shore Road, the railroad, and the Woburn Loop.

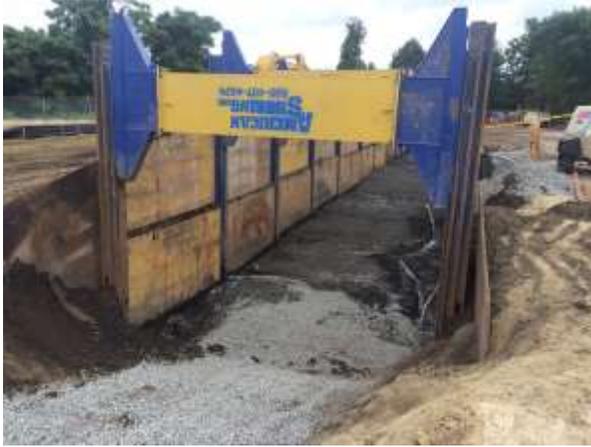
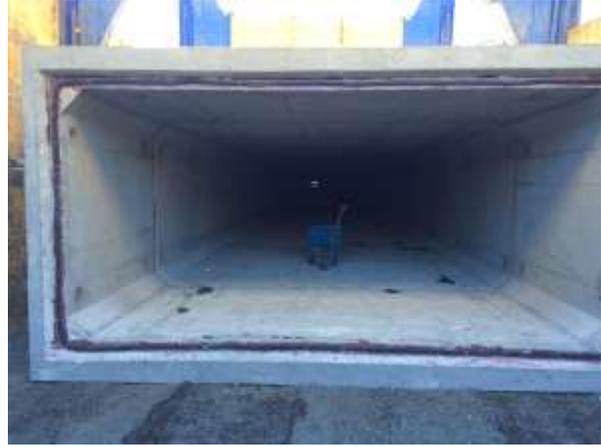
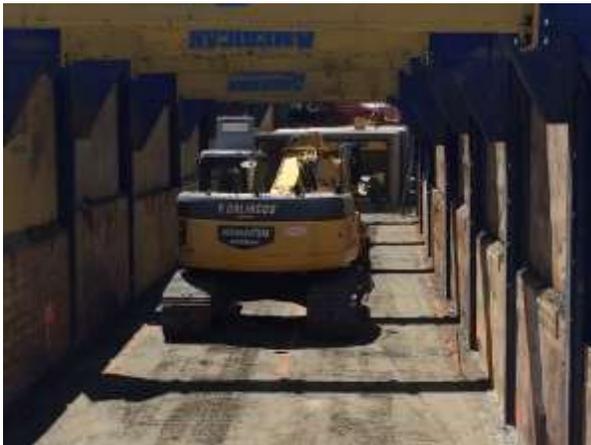
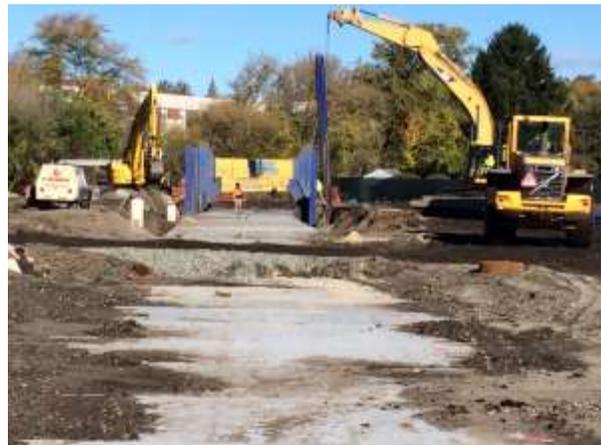
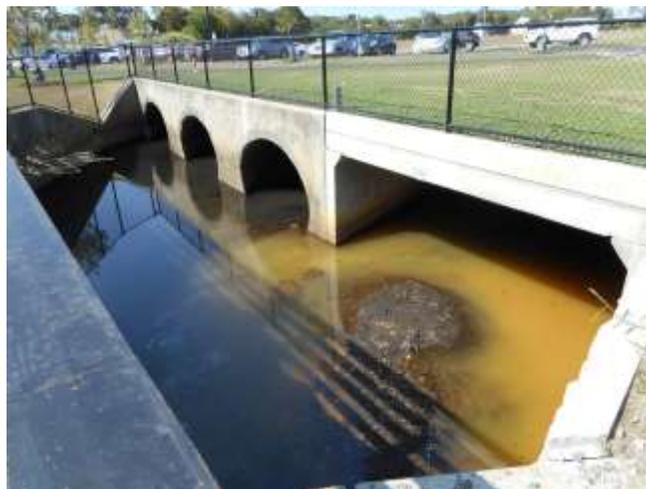
Skillings Field

- 1962 – channel dredged. The channel from Skillings Road culvert to Swanton Street dredged by Town in an effort alleviate the flooding in the low areas in the Winter Street area. The channel adjacent to Skillings Road near the Shore Road culvert was also deepened.
- 1968 – three parallel 7-foot diameter culverts, each about 1,250 feet long, were installed to carry the river water underground.
- 1971 – field began use as high-school field.
- 2017 - fourth culvert added to carry river water underground

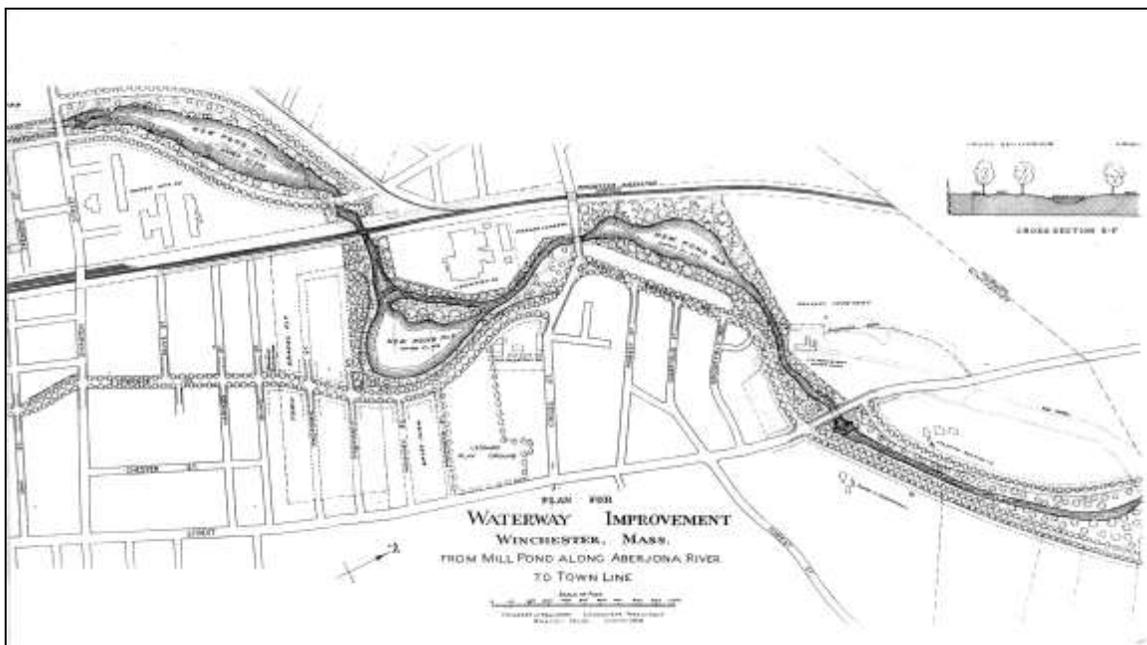
MAP 31- 1928
Kellaway Plan for Flood Expansion Ponds

ABERJONA POND TO WASHINGTON STREET

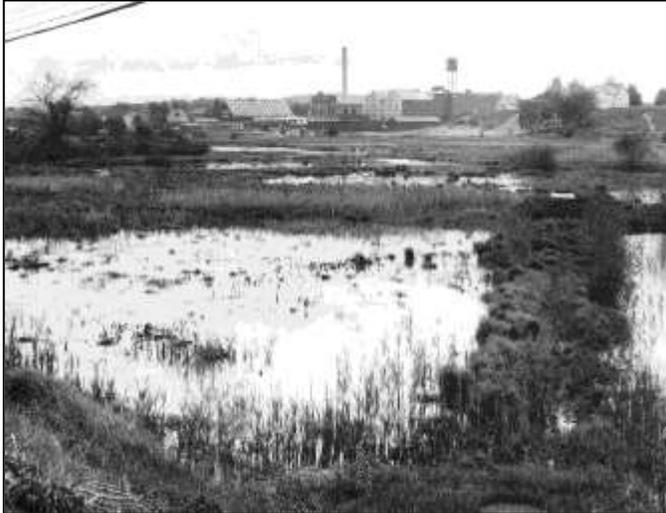
Photo: Looking South toward Swanton Street before Improvement

“For years the stream had been flowing...in a zigzag course, changing this way and that, until the whole area was permeated with sewage and debris... a home of snakes and turtles, every foot of it a breeding place for mosquitoes. ... One could not go across this land without sinking into mud from two to six feet deep.”²⁴

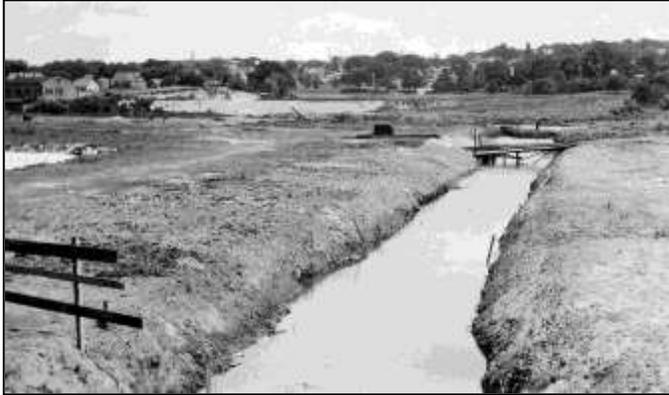
Railroad Bridge

In 1932, the channel on either side of the railroad was widened and the shores compacted, just as was done to the channel all the way to Washington Street.

This photo shows the channel leading from the bridge up to the new Leonard pond.

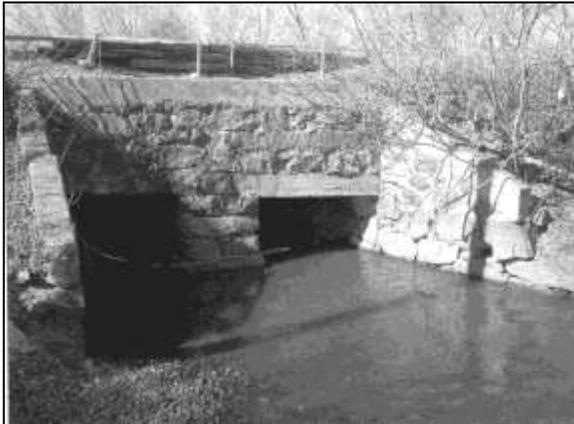
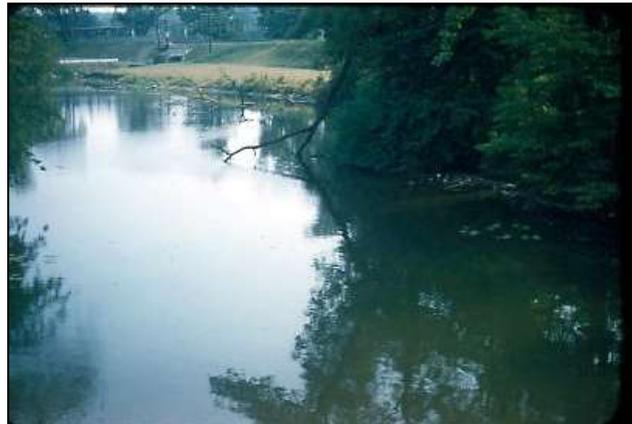
For comparison with the contemporary photo of the railroad bridge near Muraco School (below left), this picture (left) of an original railroad bridge at Shore Road is shown. This bridge was demolished in 1934. The surviving bridge was altered during the 1954-57 elevation of the railroad. The photo below right shows the channel above the railroad in the 1950s.

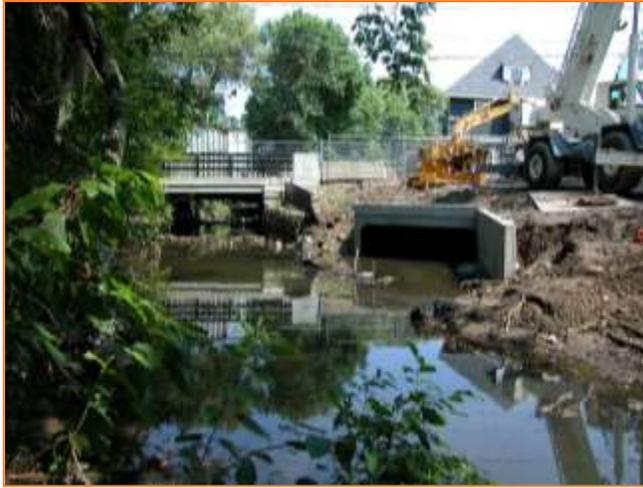
Cross Street bypass culvert

The 5'x12' bypass relief culvert next to the existing 6.5' x 16' opening increases the capacity for flow passing under the bridge during floods.

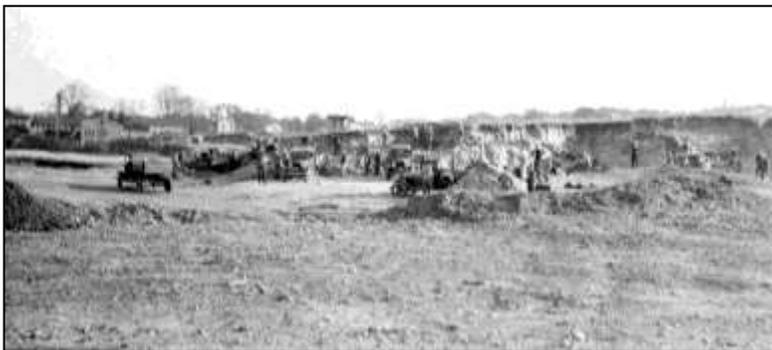
The pond was excavated, over 8,000 cubic yards of earth being taken out. Over 300,000 sq. ft. of swamp land was “reclaimed” (again using the Park Commission’s terminology). The steep bank at the rear of the field was graded so as to

give a gradual slope to the shores of the new pond. Gravel from the bank (shown above) was used to fill in the swamp below. A second dam was built near the railroad tracks to ensure the proper depth of water in this pond and another pond north of Cross Street.

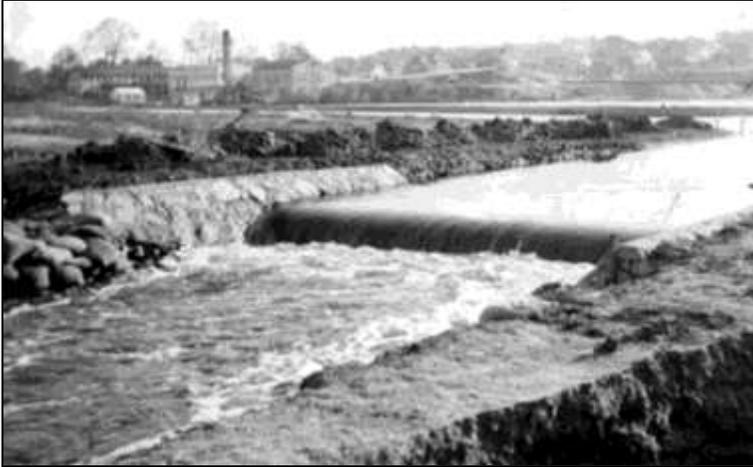
The dam and the new channel below Leonard Pool in 1932.

- 1932 – channel straightened and widened. The channel from the railroad north to the Cross Street bridge, a distance of 2,300 feet, was widened and straightened. 5,000 cubic yards of earth were removed in this operation.
- 1940 – landscaping. A row of maple trees was planted along the river bank.
- 2002 – Flood Mitigation Project. Dam below pond removed.

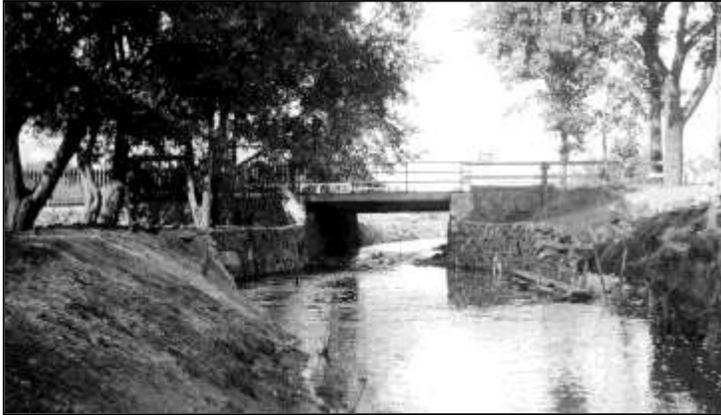
Cross Street Bridge in 1932

The Cross Street bridge was entirely reconstructed in 1914.²⁶ It was not altered during the waterways improvements of the 1930s, though stone riprapping was added to the banks above and below the bridge.

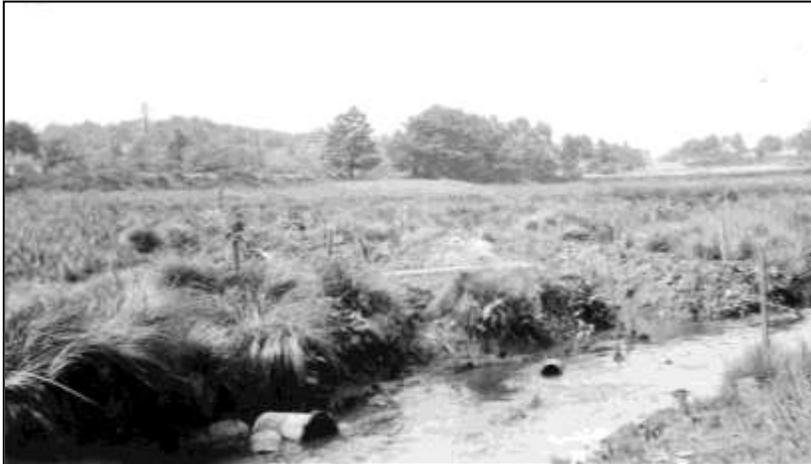
Area above Cross Street staked for new channel

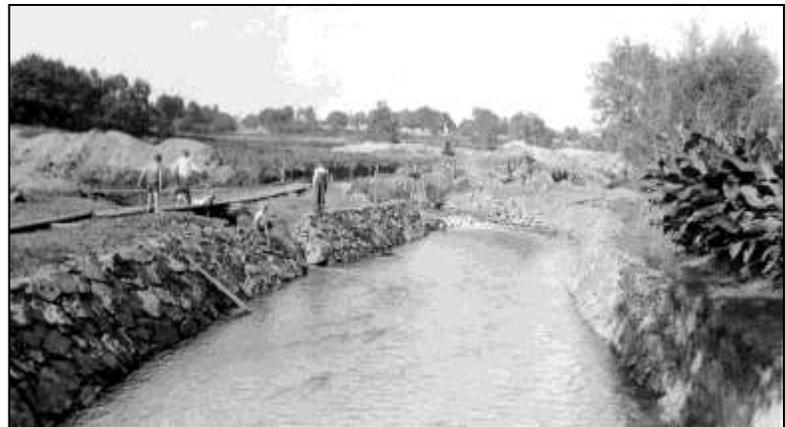
Riprapped channel near Cross Street Bridge

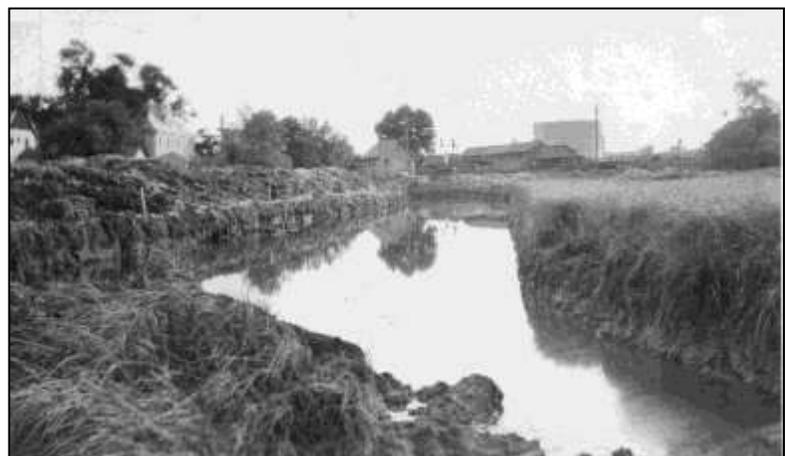
New Channel near Cross Street

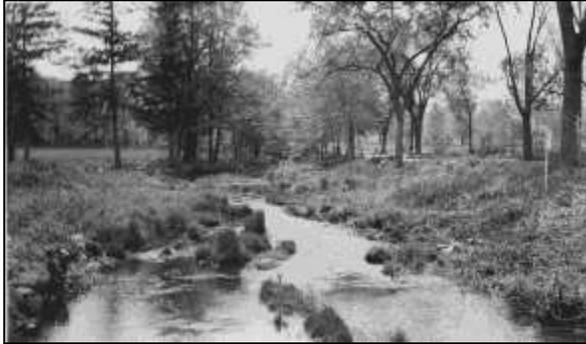
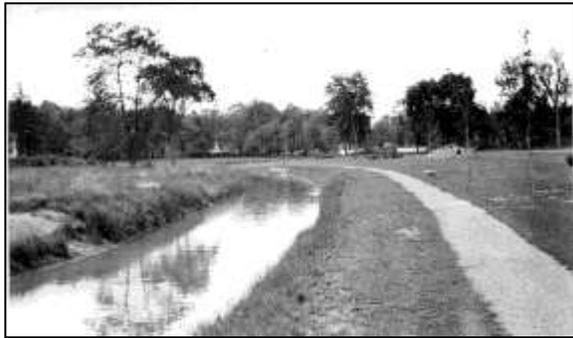
Before and After Rechanneling

- 1932 – new channel. Between Davidson Park and Washington Street, a 900-foot new channel was dug by hand and the old channel filled. 20,000 cubic yards of earth were removed and used, in part, to fill the old channel and bring the swamp land up to grade. Two dams were constructed, one just above the pond near the Winn watch hand factory and the other at Washington Street.
- 1934-35 – river rechanneled through Washington Street Park, crossing under street north of old Willow Brook channel. Old channels filled in.
- 1935 - the entire area just below the Winn factory was regraded and loamed.

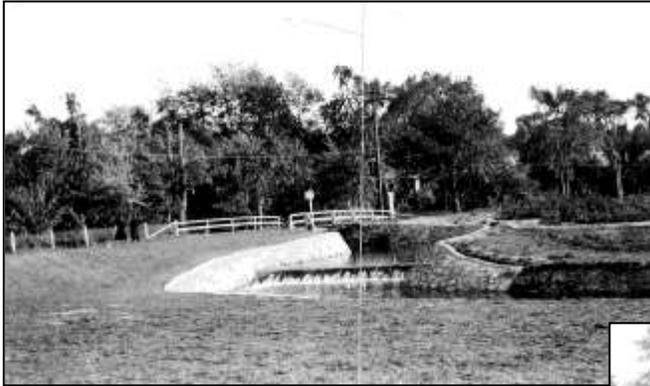
The existing bridge was built in 1934. Work included the construction of a new channel, dam, and the North Washington Street Park (see Appendix II). At this bridge, as well as the Cross and Swanton street bridges, stone riprap was laid along the channel.

New 1930s rapids

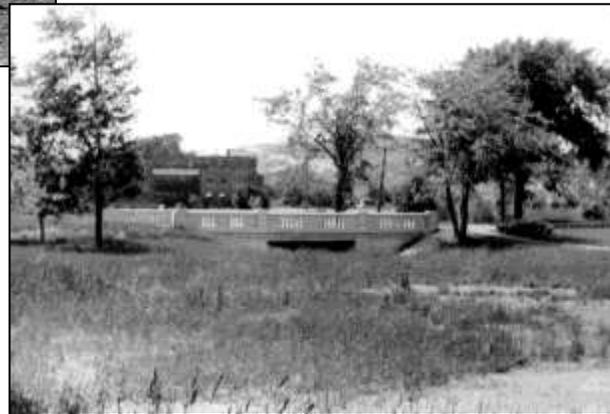
New bridge photographed in 1936

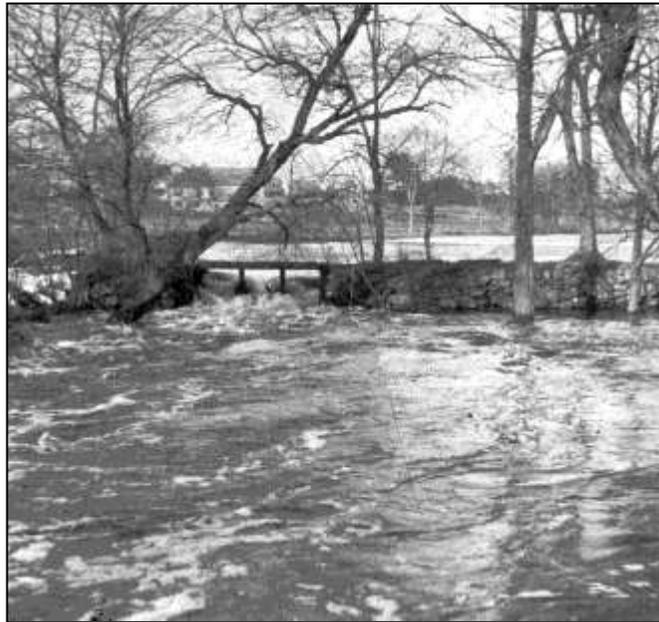
Dam at former cranberry bog above Washington Street 1901

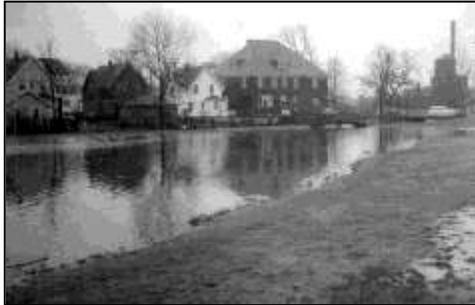
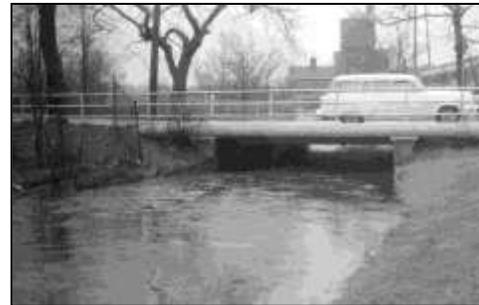
During a week and a half of stormy weather 4.55 inches of snow or rain fell, suddenly bringing the river to a flood stage. Many basements were flooded. Several businesses also called for their basements to be pumped out. Pictured below: Davidson Park and Cross St. Bridge.

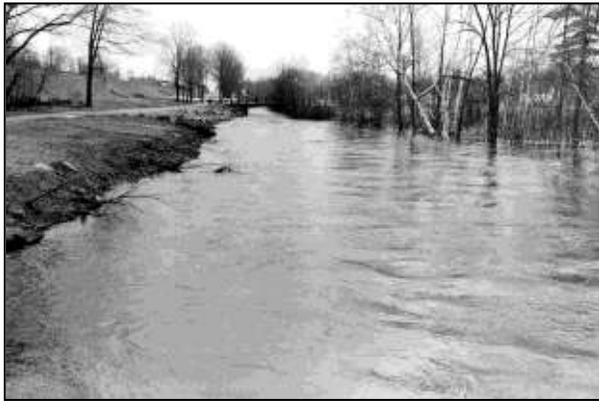
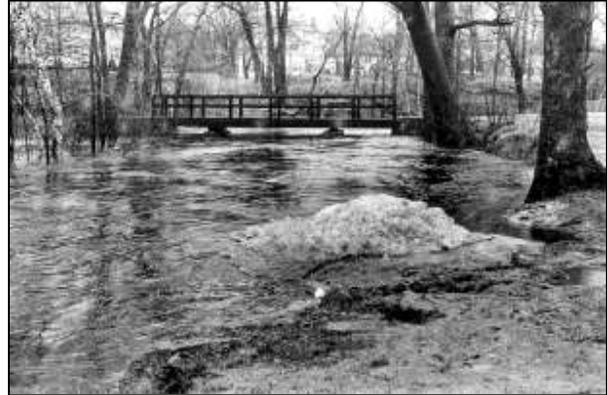
Pictured below: channel below Wegemere Road, footbridge at bottom of Mystic Ave.
