WINCHESTER PUBLIC SCHOOLS  
FACILITIES MASTER PLAN

REPORT PREPARED BY

JULY 25, 2017

## Master Plan Update

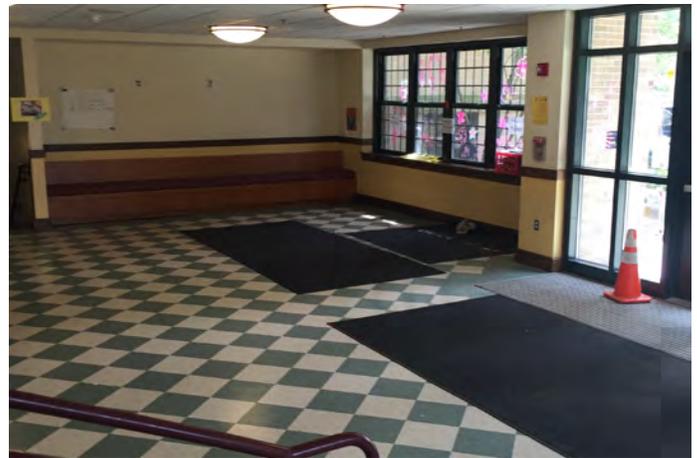
*Typical flooring in hallway*

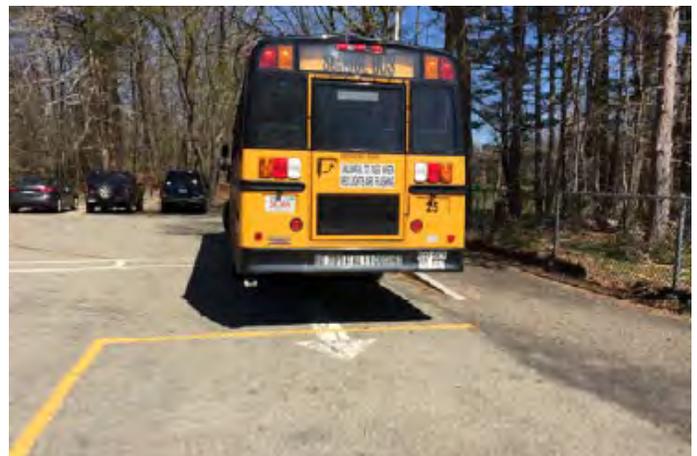
*Bus drop-off at Brantwood parking lot*

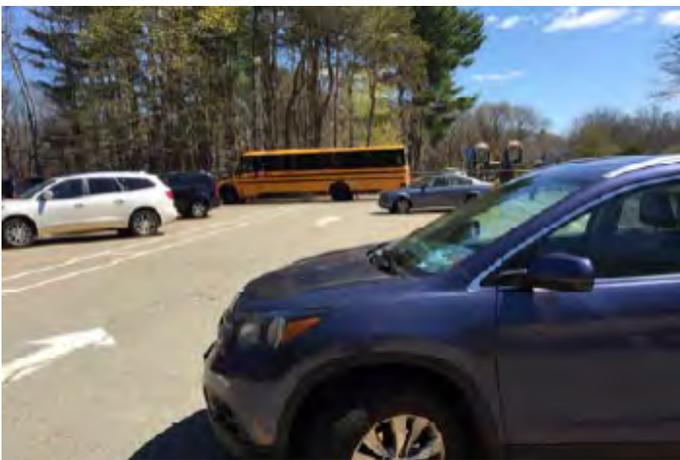
Striping at the Brantwood Road lot is confusing. There is a combination of 30 angled and perpendicular parking spaces, none of them marked accessible. There are what appear to be two painted walkways, presumably for pedestrian circulation and there are other line paint markings that appear to be within the circulation route. Only the bus drop-off is marked with a sign. The pavement is in reasonable condition with some unevenness and cracks. There is no curbing.

*One-way circulation at Brantwood lot*

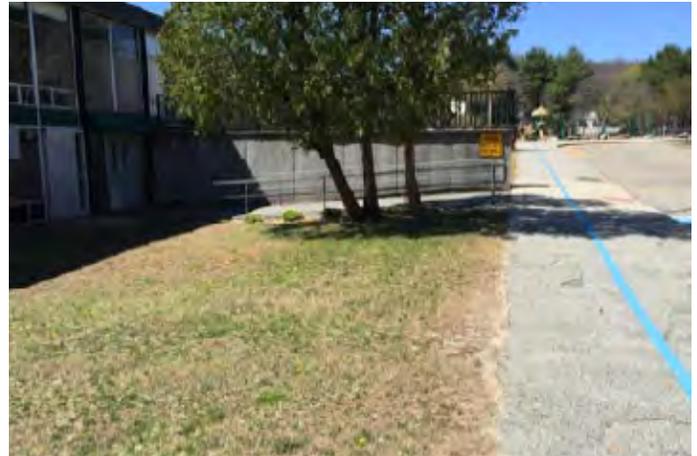
*Curbed asphalt sidewalk along the front of the building*

There are two primary entrances to the Lynch School, one from Brantwood Road and one from Horn Pond Brook Road, each with a small roundabout and associated parking areas. The pavement is in poor condition with extensive cracking and settling. The roundabouts are separated by a play area and there is no vehicle circulation through the site. Grades within the accessible parking areas do not appear to meet accessibility guidelines (less than 2% slope in any direction). Access to the site from Horn Pond Brook Road is via a small bridge over Horn Pond Brook. The bituminous sidewalk in front of the school is in poor condition with severe cracking and uneven settlement.

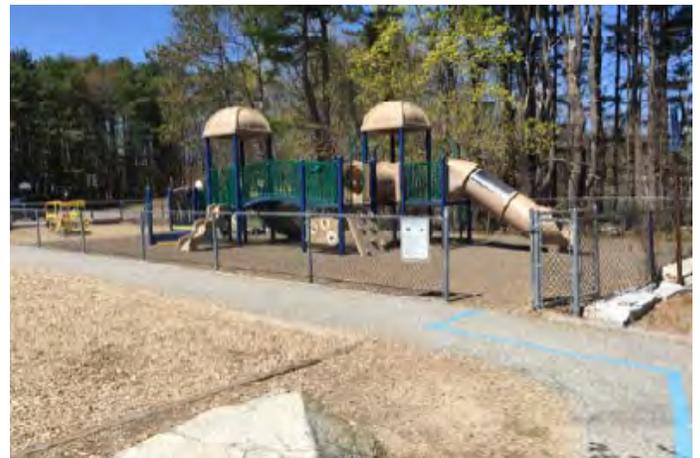
Surfacing under the Gametime structure is poured-in-place polyurethane, while the remainder of the surfacing is wood chip mulch. All the play components and surfacing are in good condition.

*Playground for younger children*

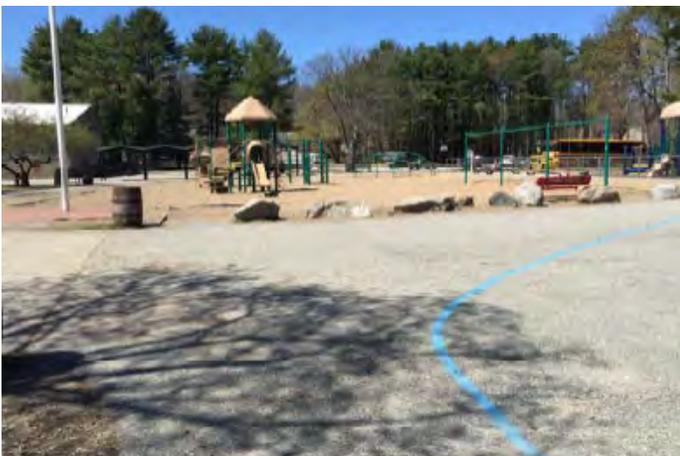
*Playground for older children*

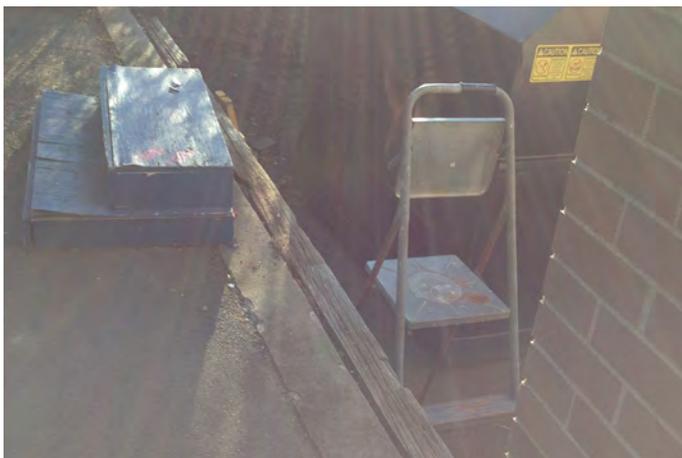
The site is bordered to the east by Horn Pond Brook. There is no fence separating the site from the brook. A bituminous path that is in fair condition runs around the school. Generally there is positive drainage away from the building. At one point the bituminous path is adjacent to the dumpster in the mechanical area. There is a three to four foot drop from the path to the dumpster area with no rail or other fall protection.

*Path adjacent to dumpster in mechanical area*

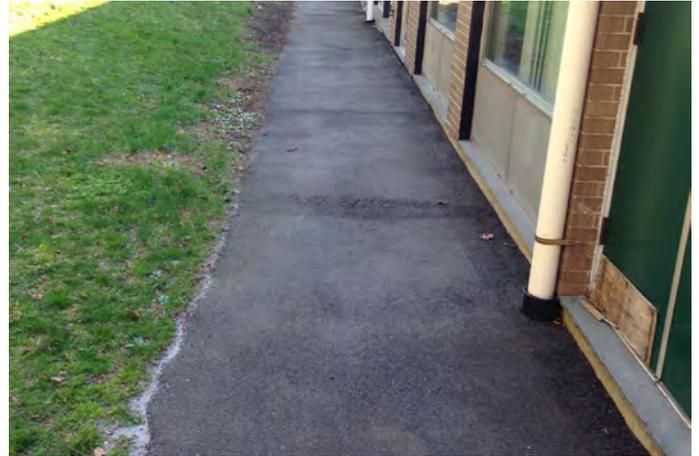
*Roof drains and downspouts*

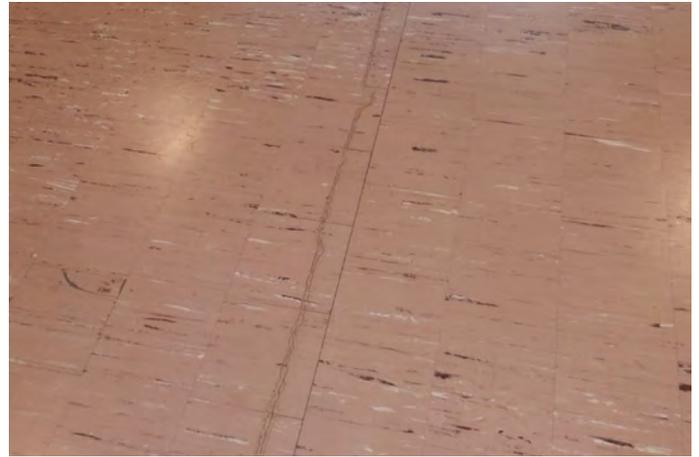
*Typical flooring*

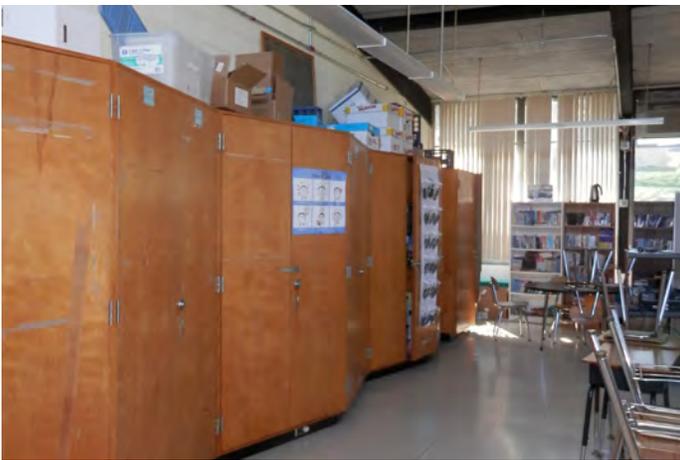
*Typical storage*

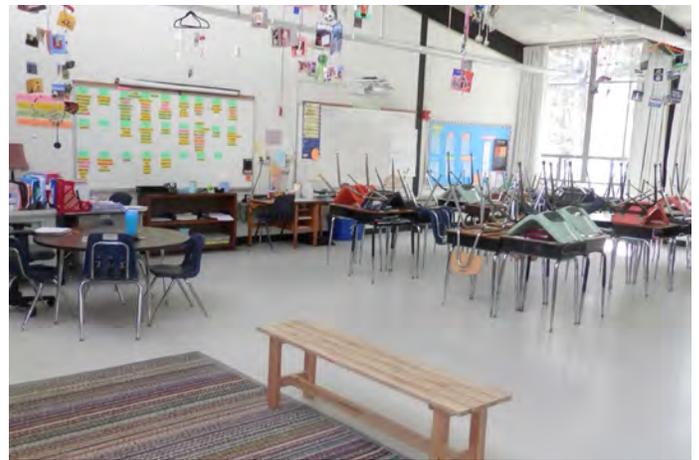
*Typical classroom*
